Performance of buildings with masonry infill walls during the 2011 Lorca earthquake

Lutz Hermanns · Alberto Fraile ·
Enrique Alarcón · Ramón Álvarez

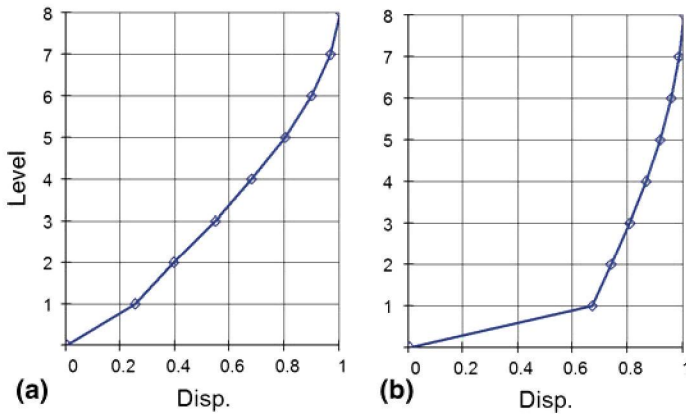
Fig. 12 Mode shapes of the building with intact (a) and with damaged (b) masonry infill wall at ground level

Lorca earthquake. The resulting fundamental period is 0.68 s and the maximum base shear force reaches 2,460 kN. The modification of the stiffness of the model drastically changes the mode shape as can be seen in Fig. 12.

In Fig. 12a the mode shape corresponding to the model with intact infill panel at ground level is shown and in Fig. 12b the one corresponding to the model with the damaged infill panel at ground level. In Fig. 13 an example is presented where two buildings pounded resulting in damaged façade elements. Pounding occurred at the floor level of the first floor as a consequence of the reduced lateral stiffness of the ground floor of one of the buildings. The reduction in stiffness was due to a cracked infill panel at ground level.

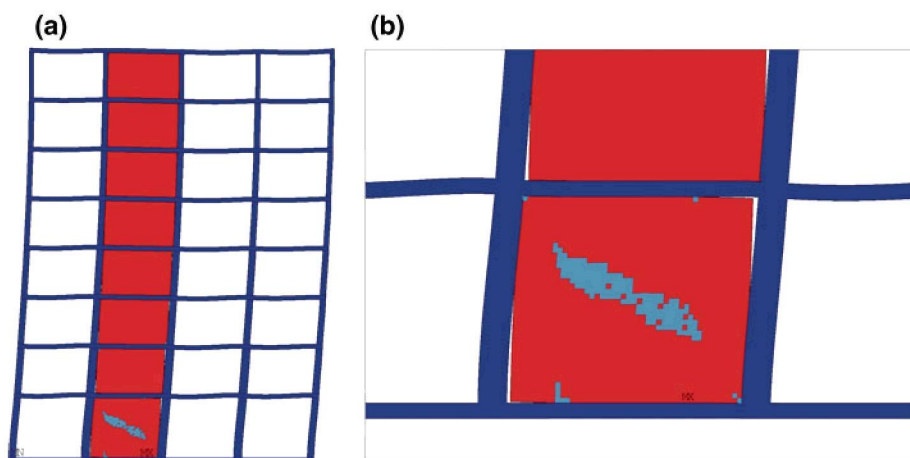
**Fig. 23** Building 1: **a** Front view of the deformed structure; **b** Detail of the infill wall at ground floor level

In Fig. 23 the configuration is shown when a diagonal crack forms in the infill panel. At this stage the relative displacement of the ground-storey is 5.3 mm which corresponds to a lateral drift of 0.12 %.

In Fig. 23b open gaps of up to 1.7 mm between the infill wall and the surrounding frame are clearly visible as well as the diagonal crack that develops in the infill panel. In Fig. 24 the contact pressures between masonry infill and columns are presented.

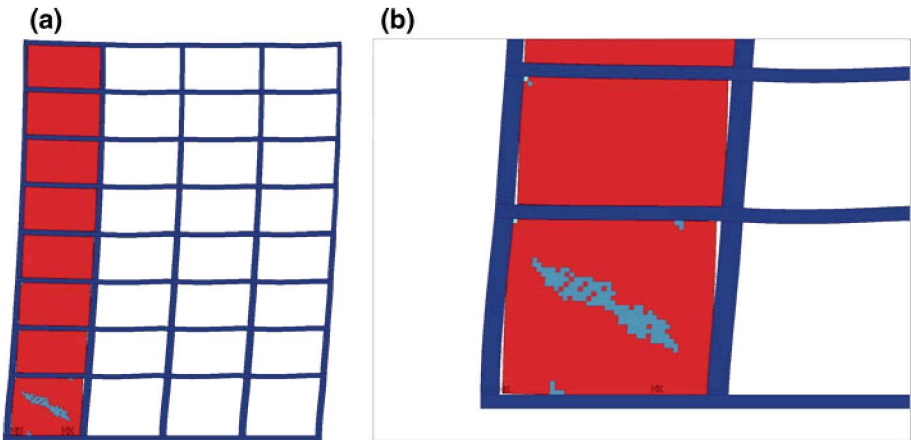
Fig. 26 Building 2: **a** Front view of the deformed structure; **b** Detail of the infill wall at ground floor level

In Fig. 26 the configuration is shown when a diagonal crack forms in the infill panel. Due to the lower stiffness of the lateral resistance system the relative displacement of the ground-storey is higher and reaches 6.3 mm which corresponds to a lateral drift of 0.16 %. In this case open gaps of up to 2 mm form between the infill wall and the surrounding frame.

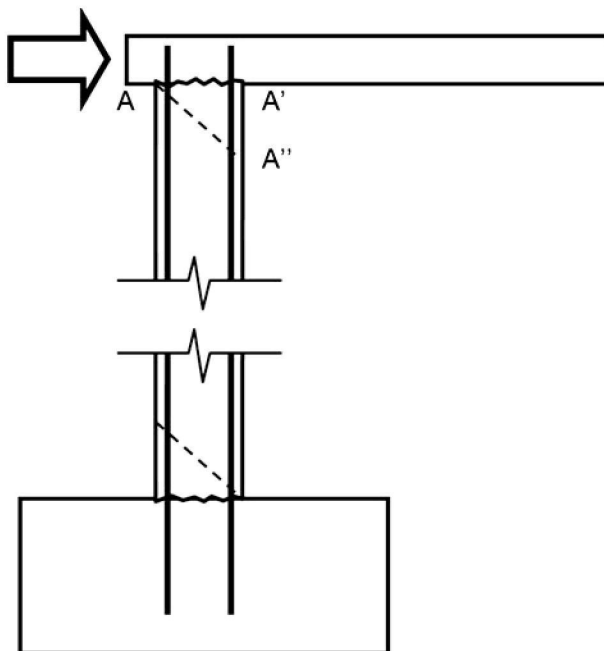
In Sect. 3 the observed failure patterns of the buildings in Lorca have been described and in Sects. 2 and 5 the shear demands in the columns of a typical eight-floor building have been estimated. In what follows two failure modes will be further studied in more detail. The first one corresponds to the failure of the beam-column junction (section A-A' in Fig. 28) and the second one to a conventional shear failure (shear failure plane A-A'') across an inclined shear-failure plane.

The capacity to prevent a sliding shear failure (section A-A') at the beam column junction described in Sect. 3.2 is according to the Spanish design code for concrete structures (EHE 2008) 769 kN. On the other hand the shear capacity of the column without shear reinforcement (section A-A'') is 182.5 kN i.e. approximately 24 % of the former one. Neglecting a possibly existing transverse reinforcement in the columns is motivated by the fact that buildings from the 1960 to 1980s were usually not provided with amounts of transverse reinforcement that could significantly contribute to the overall shear capacity of the section. However, in Lorca as well as in L'Aquila (Verderame et al. 2011) sliding shear failures like that in section A-A' occurred several times. Repeating the calculation of both capacity values for different types of concrete and column dimensions results in similar differences between both capacities. Several reasons may be given to explain the occurrence of sliding shear failures at the beam column junction. Insufficient quality control during the execution of the beam column junction may be responsible for much lower capacity values or a redistribution of gravitational forces from the columns to the infill walls as consequence of creep of the beams and shrinkage in

Fig. 28 Definition of the studied shear failure modes of columns
